WT-1408

# OPERATION PLUMBBOB

Project 1.8b

EFFECTS of ROUGH TERRAIN on DRAG-SENSITIVE  
TARGETS (U)

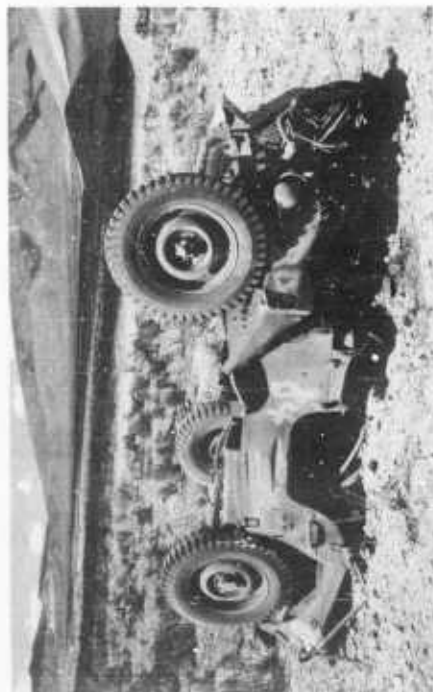
Station 6.02 (SO) 2,760 feet.

6.01	2,381 SO		10.2	630	Severe; vehicle demolished.	—	—	—
6.01	2,381 FO		10.2	430	Severe; vehicle upright, intact; body and frame ruined.	—	—	—
6.02	2,760 SO		8.8	150	Severe; vehicle upside down, body, frame, radiator, steering ruined	—	—	—

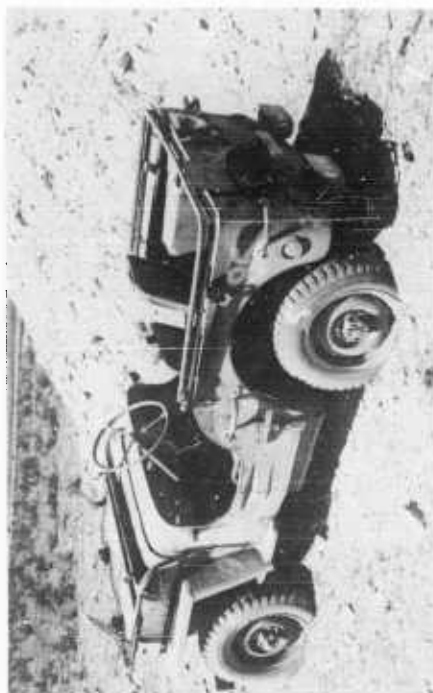
Station 6.02 (SO) 2,760 feet (behind artificial revetment).

6.02	2,760 FO		8.8	150	Severe; vehicle upright, body badly damaged, frame bent, steering mechanism bent.	—	—	—
6.02*	2,760 SO		8.8	0	Light; vehicle upright, no damage	0	0	O

less of their distance from ground zero (2,548, 2,760, 3,218, or 3,406 feet) or whether they were on level ground or hills. The vehicle behind these earth mounds received no damage, while those exposed unprotected at the same location received moderate-to-severe damage.

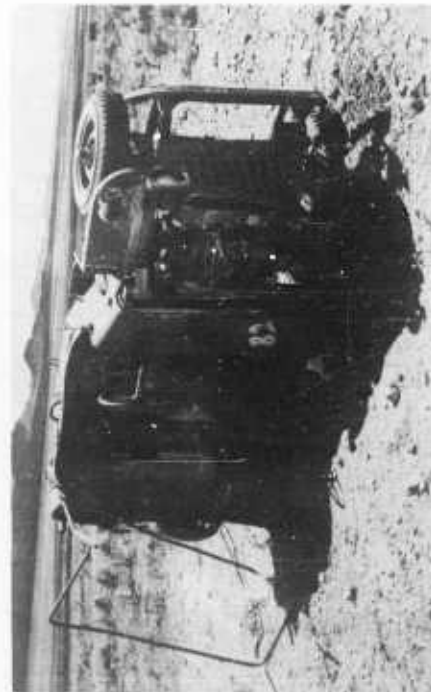
Station 6.04 (SO) 3,406 feet.

6.04	3,406 SO		6.4	110	Moderate; vehicle on right side, body severely damaged, right front wheel torn off, steering mechanism bent.	5.3	13.3	O
6.04	3,406 FO		6.4	25	Moderate; vehicle upright, radiator and body damaged.	2.0	6	O

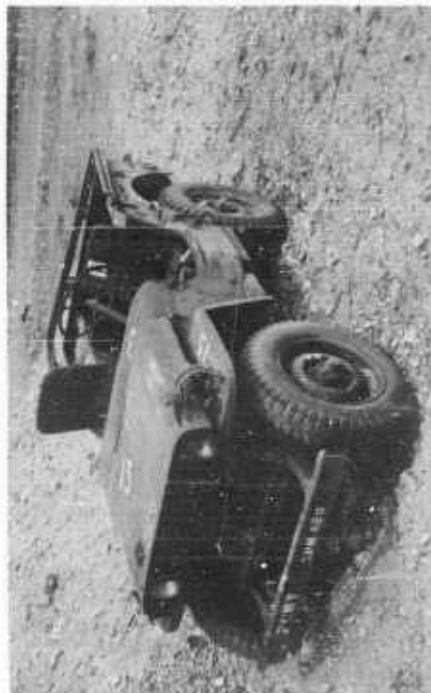
Station 6.04 (SO) 3,406 feet (behind artificial revetment).

6.04*	3,406 SO		6.4	0	Light; vehicle upright, no damage.	0	0	O
6.05	3,875 SO		7.2	20	Moderate; vehicle upside down, body badly bent, steering mechanism ruined.	3.5	9.5	O

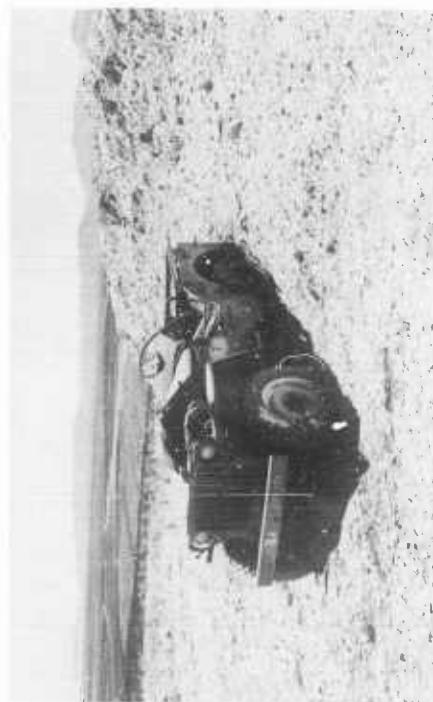
6.07*	2,548 SO	Hill	12.5	0	Light; vehicle upright, hood missing, cowlings bent, windshield broken.	0	3	O

Station 6.07 (SO) 2,548 feet (behind artificial revetment).

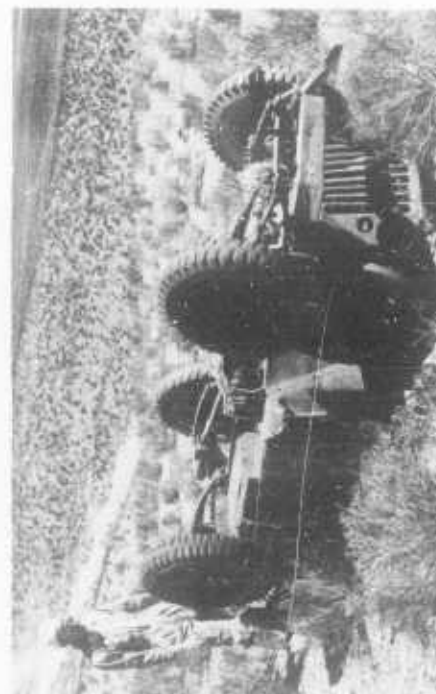
As shown in Figure 13, the damage experienced by the vehicles directly on Line 2 was identical at corresponding distances on the control line, with one exception. The side-on vehicle at Station 6.09 (a hill station) was severely damaged, while the vehicles in front of this station, as well as those equal distances on the control line, were only moderately damaged. Although severe damage is implied at this ground range, it is unusual to have those vehicles (surrounding and preceding the severely damaged vehicle) sustain only moderate damage.

Other significant examples of the protection afforded by sharp terrain features occurred at Stations 7.03 and 7.08. At Station 7.03 the vehicles survived the blast and were not damaged, while those vehicles at Station 6.09, which were at the same distance, were heavily damaged. This occurred because Station 6.09 was exposed on a hill and

6.08	2,914 FO	Dale	10.8	0	Moderate; vehicle upright, radiator ruined, hood bent, headlights broken.	1.5	4.8	O
6.09	3,218 SO	Hill	8.2	220	Severe; vehicle upside down, engine mounts sheared, body ruined, frame bent.	—	—	—

Station 6.09 (SO) 3,218 feet (hill).

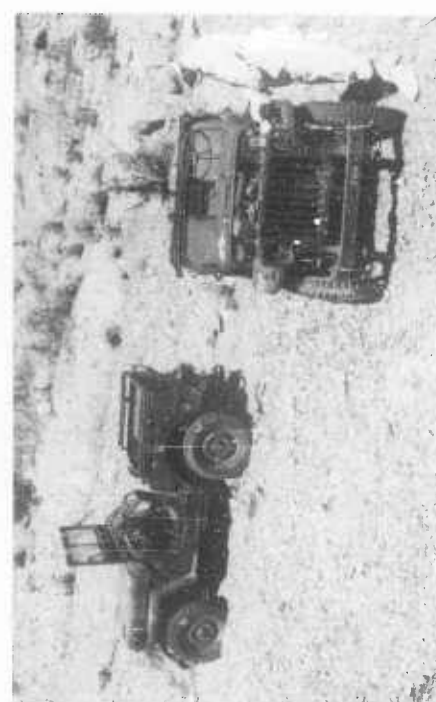
7.03	3,218 SO	Dale	9.0	0	Light; vehicle upright, scorched, seats missing.	0	0.5	O
7.03	3,218 FO	Dale	9.0	0	Light; vehicle upright, scorched, hood missing.	0	0.5	O

Station 7.03 (SO and FO) 3,218 feet (dale).

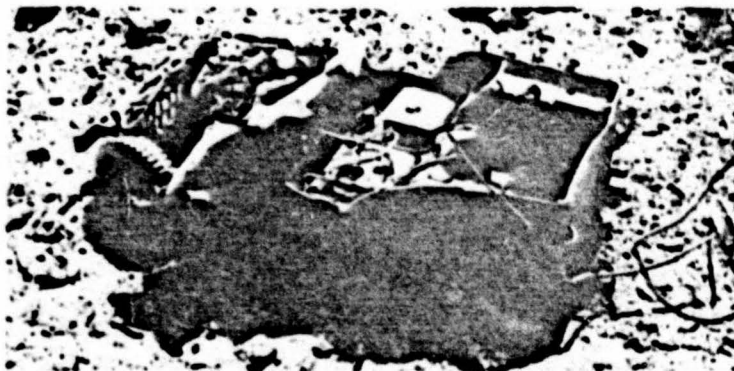
7.08	1,728 SO	Gully	54.0	0	Moderate; vehicle upright, front end of body badly damaged, radiator ruined, steering mechanism ruined.	8.5	14.5	hour	F
7.08	1,728 FO	Gully	54.0	0	Moderate; vehicle upright, front portion of body crushed, radiator and steering ruined.	9.0	18	hour	F

7.03 was shielded by a bluff. An even greater contrast in damage was observed between Stations 6.13 and 7.08. Station 6.13 (1,836 feet) was completely demolished, while 7.08 (1,728 feet and well within the 90-percent-severe-probability radius) was only moderately damaged. The apparent reason for this was that Station 7.08 was located in a narrow gully which provided shielding as well as restriction of movement (Figure 15).

Station 7.08 (FO) 1,728 feet.

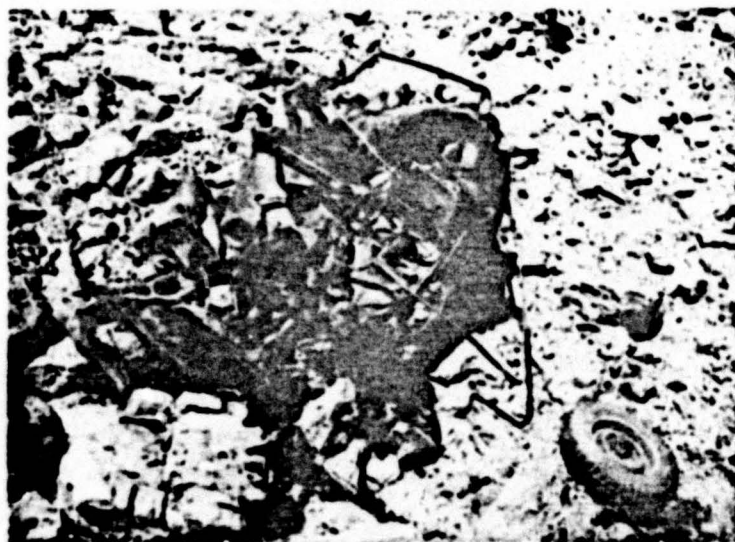
6.13	1,836 SO	Ravine	24.5	100 to 1,500	Severe; completely dismembered.	—	—	—	—
6.13	1,836 FO	Ravine	24.5	100	Severe; completely demolished.	—	—	—	—
7.06	2,341 SO	Back of Hill	15.7	100 to 600	Severe; vehicle upside down, engine and grill attached to frame, body stripped.	—	—	—	—

Station 6.13 (FO) 1,836 feet.

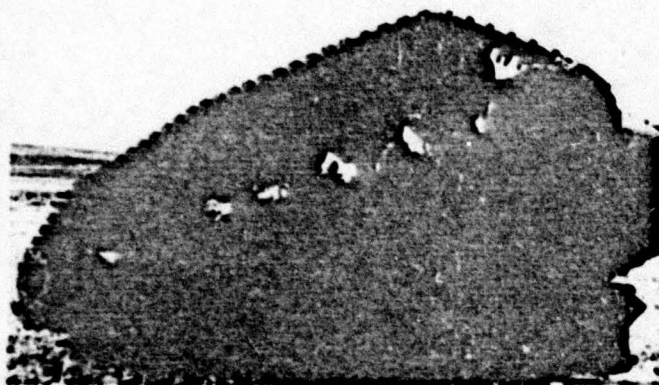
7.07	2,975 FO	Gully	11.6	5	Moderate; vehicle upright, radiator destroyed, steering wheel and column bent.	4.0	7.8	hour	O
9008	1,231 SO	—	65	15	Severe; vehicle upside down, burned, engine melted.	—	—	—	—

Station 9008.
